**PERFORMANCE OF CS-SLEEVE UNDER DIRECT TENSILE LOAD:
PART I: FAILURE MODES**

Abstract: Tensile resistance of a sleeve connector used to connect between two structural components by confining grouted reinforcement bars relies on the bond interaction among reinforcement bars, sleeve and grout. Slippage of the reinforcement bars is customary cause of damage in end-to-end grout-filled reinforcement connector under direct tensile force. In this study, a total of nine specimens with different configuration, in terms of sleeve lengths, sizes, configurations, rebar surface conditions and grouting material, were subjected to tensile test. This paper presents the result obtained from tests conducted on the proposed CS-Series specimens and discusses the failure mode as well as the mechanisms that governed the tensile resistance of the specimens. The test data indicates that threads on reinforcement bar had significantly deteriorated the bonding mechanism between reinforcement bars and grout. None of the specimens could achieve the required strength. However, the understandings of the causes of failures obtained from the study provided essential basis for future research.

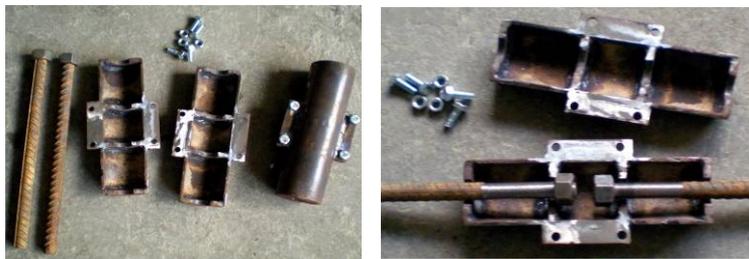
Figure 4: Preparation of specimens

The mild steel sleeves were manufactured in factory before being grouted in laboratory. Figure 4 illustrates typical design of the proposed sleeve. Steel plates were welded in the sleeve to prevent nut ended reinforcement bars from being pulled out of the sleeve. The semi circular sleeves were hold together by the bolts and nuts that grabbed on the steel plates that attached to the edge of the sleeves. Figure 5 presents the casting of the specimens with non-shrink, high strength grout in the laboratory.

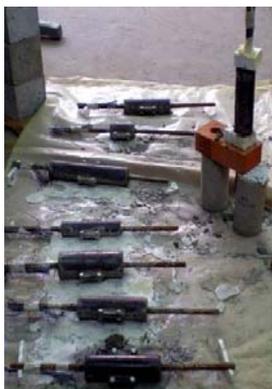
Figure 5: Casting of specimens

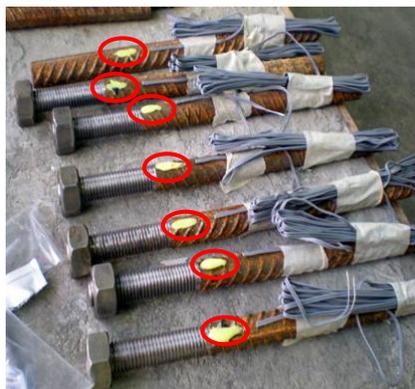
Figure 6: Installation of strain gauges on the reinforcement bar

In order to acquire the strain condition of reinforcement bars during testing, electric resistance strain gauges were installed onto the surfaces of reinforcement bars. The surfaces of reinforcement bars were grinded cautiously to procure smooth surfaces at about the size of strain gauge, so that strain gauge can attach on it firmly. The strain gauges were then covered by polyester (Figure 6) before it was tapped with a vinyl/mastic tape for insulating and moisture sealing. Besides that, strain gauges were installed on the mild steel sleeve (Figure 7) to monitor responds of the sleeve under loading.

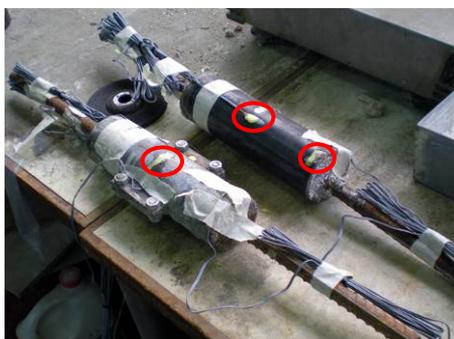
Figure 7: Installation of strain gauge on the steel sleeve

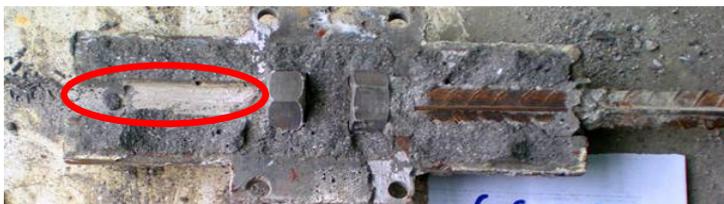
Figure13: Dusty, smooth surface Of grout due to bar slippage of specimen CS-09

All the specimens except CS-06 presented slippage of reinforcement bars as the major cause of failure. The reinforcement bars of the specimens slipped, leaving behind dusty smooth surface of grout. It was resulted due to crushing of grout key and slipping of reinforcement bar from the grout (Figure 13).

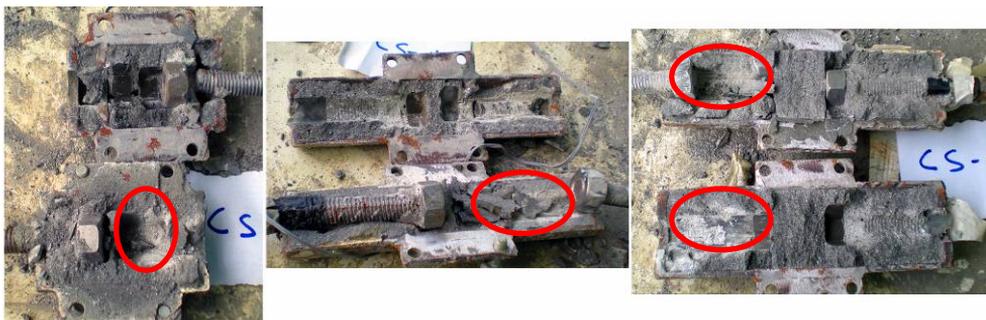
Figure 21: Crushing zones of the specimens CS-02, CS-04 and CS-05 due to excessive compression

Specimens CS-02, CS-04 and CS-07 ended up with excessive compressive force that crushed a portion of grout. It was noticed that all of the specimens that underwent crushing had their nuts remain firmly on reinforcement bars (Figure 21). Figure 20 describes the crushing mechanism of grout under confined situation for specimen CS-07. The grout was surrounded by steel sleeve which act as restrain at all directions. As pulling force was applied on reinforcement bar, the nut that clamped on rebar tended to move upward together with reinforcement bar, forming distributed force heading the direction of source of pulling force. Then the steel sleeve that confined the grout will generate resisting force at the opposite direction (Figure 22a). This situation forced compressive force onto the grout, causing the grout to deform and expended laterally. However, the sleeve wall causing significant increase of compressive force (Figure 22b) then resisted the lateral expansion. As the compressive force exceeded the compressive strength of the grout, it crushed (Figure 22c).

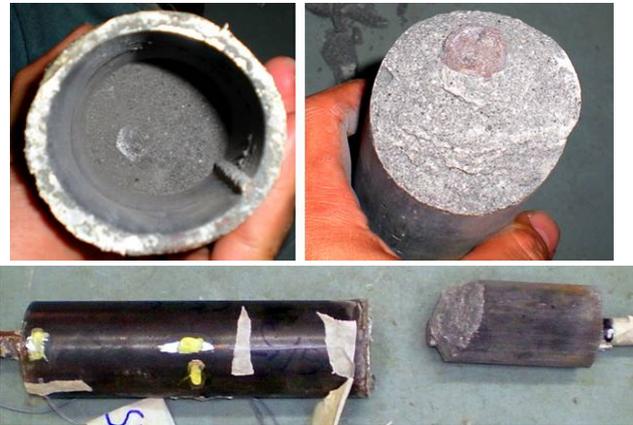
Figure 26: The grout split at the middle and slid out of the cylinder of specimen CS-06

Specimen CS-06 comprised a steel cylinder without any capping at both end of the cylinder. It confined the grout at lateral direction only. As tensile load was applied, the stress was transferred along the rebar and to the grout through bonding mechanism. Due to strong mechanical interlocking bond between bar ribs and grout, the grout tended to move as a unit with rebar, toward the direction of pulling force. Unfortunately, the contact surface between the grout and the steel cylinder was smooth without provision of any ribs on it. This caused the top part and bottom part of grout tended to moved and slid at opposite directions. Due to the reason that grout is strong in compression but weak in tension, it split into two components and one of the grout slid out of the cylinder with the embedded rebar. Figure 25 and Figure 26 present the failure mode of specimen CS-06 and the surface of split of the grout.
