PERFORMANCE OF CS-SLEEVE UNDER DIRECT TENSILE LOAD, PART II: STRUCTURAL PERFORMANCE

ABSTRACT: Tensile resistance of a sleeve connector used to connect between two structural components by confining grouted reinforcement bars relies on interaction among reinforcement bars, sleeve and grout. In this study, a total of nine specimens with different configurations, sizes of sleeves, reinforcement bars' surface conditions and also grouting materials were tested under direct tensile tests. This paper presents further discussion on the study of performance of CS-Sleeves, particularly on the load-displacement graphs and load-strain graphs of the specimens in order to acquire the structural performance of the specimens. The test data indicates that threads on reinforcement bar had significantly deteriorated the bonding mechanism between reinforcement bars and grout. None of the specimens achieved the required strength. However, the findings obtained from the study provide essential basis for future research in developing an adequate sleeve connector.

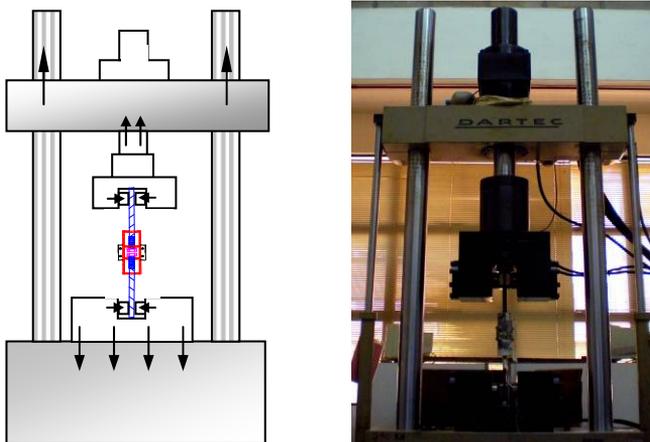
A total of nine specimens were proposed to be tested under direct tensile load in the laboratory. Figure 1 demonstrates the setup of the hydraulic actuator for direct tensile test. Specimens were placed vertically on the platform while the actuator grabbed on the reinforcement bars at both ends at 11MPa pressure. Then, as the testing launched, the arm of the hydraulic actuator moved upward, causing incremental pulling force onto reinforcement bars at opposite directions. The rate of pulling was 0.2kN/s throughout the testing. The data obtained from the testing consisted of load (kN), displacement (mm), steel strain ($\times 10^{-6}$ mm/mm) and also sleeve strain ($\times 10^{-6}$ mm/mm). The variation of load was plotted against displacement and strain reading for analysis.

Figure 1: Tensile test were conducted in laboratory

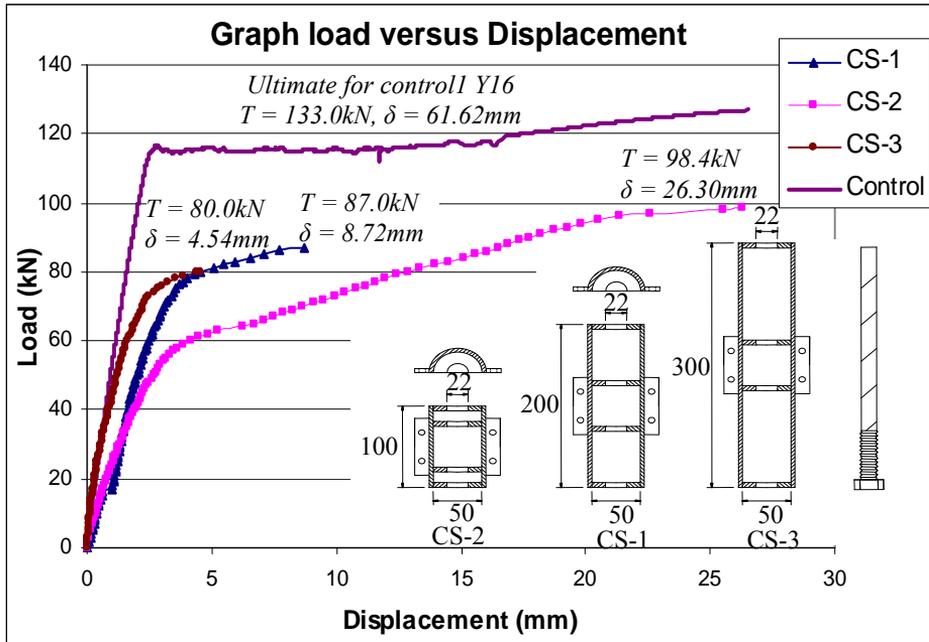
In this study, CS-Sleeves were tested under incremental tensile load to acquire their ultimate capacities and loading behaviour. A Y16 reinforcement bar was used as the control specimen to evaluate the structural performance of the proposed sleeves. The Y16 bar showed elastic behaviour (constant in load-displacement slope) before it yielded at 114.5kN load. Beyond that, its stiffness dropped drastically and it endured serious elongations (interpreted from drastic decrease of load-displacement slope after 114.5kN). The ductile behaviour could be observed through fluctuation of the load-displacement curve after it yielded. Y16 bar failed at ultimate capacity of 133.0kN, with the corresponding displacement of 61.62mm. Figure 2 shows the graph of load versus displacement for specimens CS-01, CS-02 and CS-03. The effects of different heights of the sleeves to the structural performance of the specimens were studied. Specimen CS-01 could sustain up to 98.4kN of loading with corresponding displacement of 8.72mm. Basically, it is almost impossible for a sleeve to produce perfect identical stiffness ratio as compared to the control specimen because; (1) the discontinuity of reinforcement bar, (2) the load were to be transferred among different materials, which include steel bar, grout, and sleeve. In other word, as the pulling force applied on the reinforcement bar, the load will be transferred from the reinforcement bar to the surrounding filling material (grout). The discontinuity of the reinforcement bar led to stress to be concentrated at the break point between them. The pulling force tends to break the grout, of which is weak in tensile, and causes it to split and slide out of the sleeve. Then, the sleeve plays essential role in preventing the grout from sliding out of it. Therefore, the stresses are transferred among the different material. Due to the reason that the loads were transferred among materials with different elastic modulus, CS-01 presented slightly less stiffness ratio as compared to control specimen. The gradual decrease in stiffness ratio of CS-01 triggered as the grout reached its compressive strength, when cracks and crushes initiated.

CS-01 presented an unusual increase in displacement (fluctuation) at 17kN. The comparison among other specimens with the similar failure mode, such as CS-02, CS-03, CS-06 and CS-09, shows that only CS-01 had such unusual fluctuation event occurred during loading period. It was suspected that the fluctuation was due to the slippage of the nut out of the reinforcement bar. The reason that load-displacement graph of the other specimens did not fluctuate is either (1) the nuts were yet to slip until the ultimate capacities of the specimens were reached, or (2) the slip and the displacement of reinforcement were unobvious.

Figure 2: Graphs of load versus displacement of specimen CS-1, CS-2, CS-3 and control specimen 1Y16

From the load-displacement graph in Figure 2, specimen CS-01 showed elastic behaviour for a short instant after 17kN before its stiffness started to decrease gradually at approximately 70kN load. The stiffness ratio was interpreted from the slope of load-displacement graph. The gradual decrease of stiffness ratio was governed by gradual increase of displacement, of which was contributed by (1) propagation and development of minor cracks and crushes of grout surrounding the reinforcement bar, (2) slight slip of reinforcement bar along the embedded length before the mechanical interlocking of between the ribs and the grout keys took effects, (3) slight elongation of reinforcement bar under tensile load, (4) damages and yielding of the threads.

Specimen CS-01 offered the ultimate loading capacity of 86.956kN with the corresponding displacement of 8.720mm. The results were unsatisfactory as it could only reached 65.4% of the required loading capacity. The causes of failure was discussed in *Part I* and was identified to be contributed by (1) poor bonding property between threaded reinforcement bar and surrounding grout and (2) low shear resistance capacity of the threads on reinforcement bar and the nut, causing the nut could not contribute in enhancing the effective bearing area to resist the slippage of reinforcement bar.

The reinforcement bars in specimen CS-02 had limited amount of length embedded in the grout (Figure 7). It led to less bonding capacity. Therefore, it showed the least stiffness ratio as compared to CS-01 and CS-03. This was interpreted from the instance when the displacement of the reinforcement bar accelerated (Figure 2). CS-02 underwent sudden increase in displacement at approximately 62kN load (the corresponding displacement was 5.1mm). The grout in the sleeve crushed at the instant. This caused the reinforcement bar to slip and directly contacted onto the steel plates in the sleeve. This explains the reason of sudden displacement at 62kN. The plates prevented the reinforcement bar from being pulled out of the sleeve. By then, the loading resistance of CS-02 was contributed by the strength of the nuts and the tensile resistance of the sleeve. Therefore, metallic ductile behaviour was observed from the load-displacement graph.

Among the specimens CS-01, CS-02 and CS-03, CS-03 had the longest embedded length of the reinforcement bar in the grout (Figure 7). Hence, it provided the largest stiffness ratio. CS-03's stiffness ratio was closed to the control specimen before reaching 45kN load. Then, the stiffness ratio decreased gradually. At 70kN, the degradation rate of the stiffness ratio accelerated due to rapid propagation of minor cracks and crushes in the grout. Its ultimate loading capacity was only 80.049kN (60.2% of the required strength). The corresponding displacement was 4.541mm. Although specimen CS-03 had the longest embedded length in the grout, it had the lowest loading capacity. The variation of ultimate load may due to poor quality of work, of which cause by poor compaction and improper bond between reinforcement bar and the grout. It was also noticed that the quality of thread also doubtful. Obviously, in CS-02, as the grout crushed, the specimen relied on the nut to give the resistance until it failed at 98.4kN. However, CS-01 had its nut sheared off at 17kN only. Therefore, the quality of the threads was not assured.

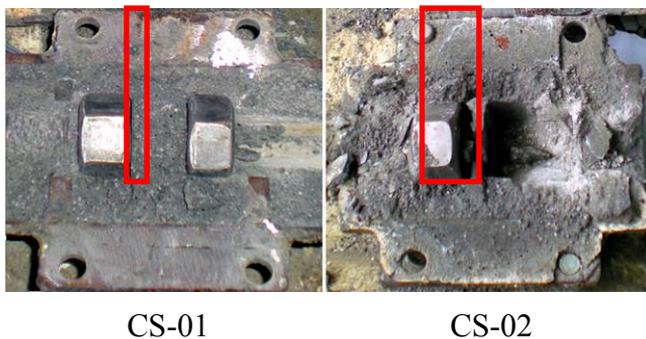
The nut that clamped on the reinforcement bar in CS-01 was located too closely to the steel plate at the middle of the sleeve, causing such an unusual fluctuation in load-displacement graph. Poor working quality caused the nut was not precisely placed at the intended location in the sleeve. Figure 3 compares the locations of nuts in specimens CS-01 and CS-02, of which CS-01 had its nut placed closely to the steel plate at the middle of

the sleeve as compared to specimen CS-02. This led to the phenomenon that as if the nut directly contact onto the steel plates in the sleeve. Hence, it provided no tolerance for slippage of reinforcement bar.

Figure 3: Comparison of volume/area ratio of specimen CS-01 and CS-02

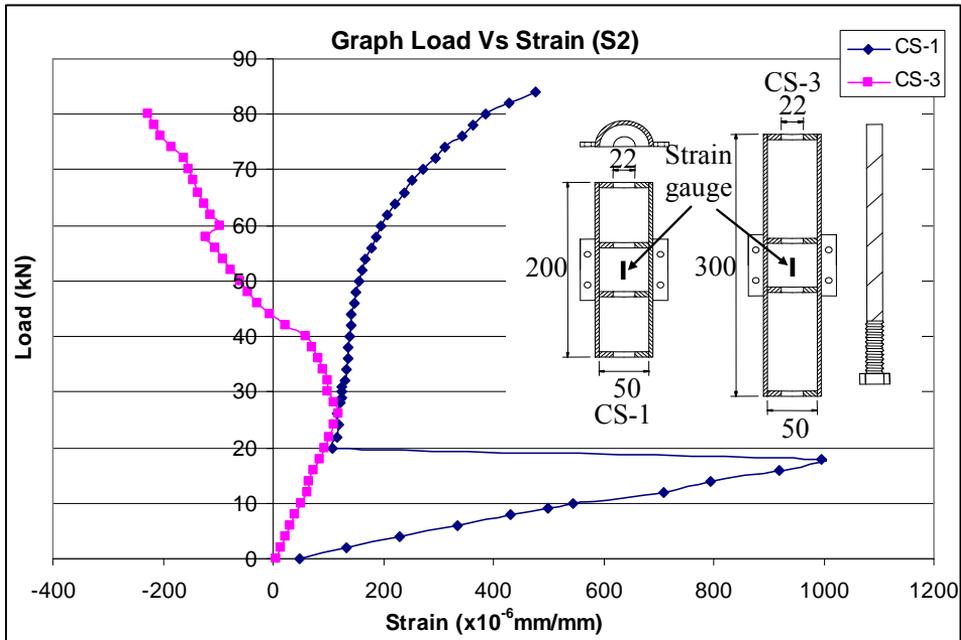
Figure 4 shows the load-strain graph of the mild steel sleeve that monitored the tensile condition of the sleeve throughout the testing. The strain of CS-01 sleeve increased linearly along with the incremental load before 17kN. Then, the strain reading dropped drastically after 17kN, of which exactly the same instant when the load-displacement graph fluctuated. It indicated the load was transferred directly from reinforcement bars to the sleeve, causing it to undergo tensile force as well. Then as the thread on the nut reached its shear capacity at 17kN, it slipped and could no longer transfer the load to the sleeve. Therefore, the mild steel sleeve was released from tensile force, which was indicated by the drastic decrease of the strain reading. Obviously, unless the nut was directly contact to the steel plate, it was not possible that the pulling force could transferred directly to the sleeve and developed a linear relationship between the respond of sleeve towards the loading applied on reinforcement bar.

Figure 4: Graph load versus strain (S2) for specimen CS-01 and CS-03

Figure 4 shows the load-strain graph that describes the tensile condition of mild steel sleeves of the specimens CS-01 and CS-03. The results obtained from the tensile test on a Y16 reinforcement bar showed that the maximum stress that could be sustained was 581N/mm². The elastic modulus of a high yield steel bar is 200GPa. Therefore, the reinforcement bar will yield at 2.905×10^{-3} mm/mm strain. The load-strain curve of the mild steel sleeve of specimen CS-03 showed negligible strain development. This indicated that the sleeve did not contribute in tensile resistance throughout the loading period. The poor bonding property between grout and threaded reinforcement bar led to improper distribution of stress in the sleeve. The reinforcement bars slipped before the sleeve could take part in resisting tensile force. Therefore, the mild steel sleeve did not take part in loading resisting mechanism.

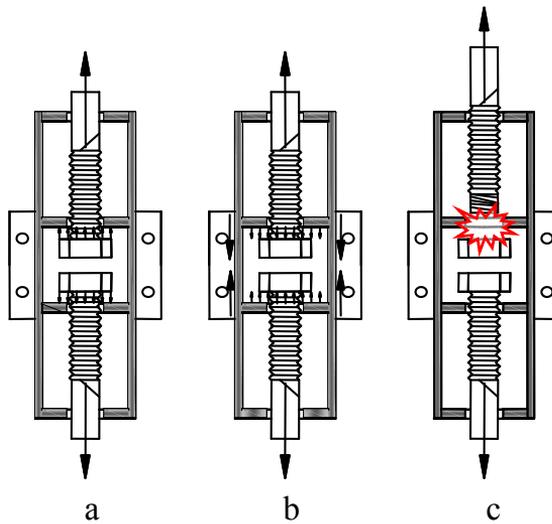
The load-strain graph of CS-01 sleeve provides essential information on responds of the sleeve throughout the loading period. Figure 5 describes the responds of the CS-01 sleeve under loading. As the pulling force applied, the nut tended to move towards the direction of the force (Figure 5a). However, it was resisted by the steel plates in the middle of sleeve, causing the sleeve to endure tensile force directly (Figure 5b). This led to linear development of the strain reading as the pulling force increased. Then, as the incremental tensile force proceeded and reached the shear capacity of the threads at 17kN, the nut sheared off and could no longer transfer load to the middle steel plate of the sleeve. Hence, CS-01 sleeve was released from tensile force and reformed back to original condition (Figure 5c), and therefore, the strain reading dropped suddenly in great intense as showed in the load-strain graph.

Figure 5: Mechanism of load transfer between reinforcement bar and sleeve

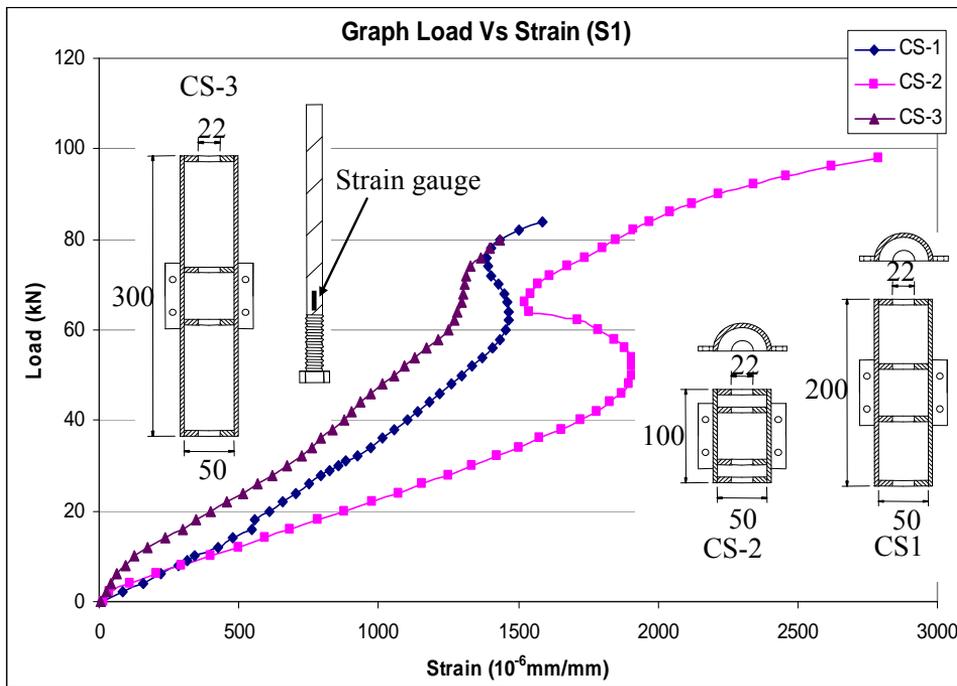
Figure 6 presents the strain condition of the reinforcement bar in the sleeve. It also provides clues for the slip of the nut. At 17kN an unsmooth curve could be detected. It indicates a temporary retard of the strain development in reinforcement bar at the instant. At the instant, the nut sheared off and the reinforcement bar slipped slightly. This led to sudden relieve of the reinforcement bar from the tense applied onto it. Therefore, the development of strain condition in reinforcement bar retarded a while in load-strain graph in Figure 6.

Figure 6: Graph load versus strain (S1) for specimen CS-01, CS-02 and CS-03

Figure 6 shows the load-strain graph of the reinforcement bars in specimens CS-01, CS-02 and CS-03. CS-02 underwent more severe strain throughout the testing because of the limited embedded length of reinforcement bar in the grout. Meanwhile, the reinforcement bars in CS-03 endured least strain as it had longer embedded length in grout. Obviously, the grout surrounding the reinforcement bar also took part in load resisting mechanism and could directly influence the stiffness ratio of the specimens. The load-strain graph also gave information that the stress in reinforcement bars in the specimens increase gradually until certain limits, then the strain reading dropped slightly. After that the strain reading increased again. This situation was due to the reason that the grout had reached to its yield, where minor cracks and slight slips occurred. The slight slip of reinforcement bar caused the instance release of reinforcement bar from the tension load. Soon after that, when the slight slip ended, the incremental load will lead further development of tension condition in reinforcement bars. Due to limited embedded length of the reinforcement bars in the grout for CS-02, it was noticed that it underwent slippage slightly earlier than the other specimens.

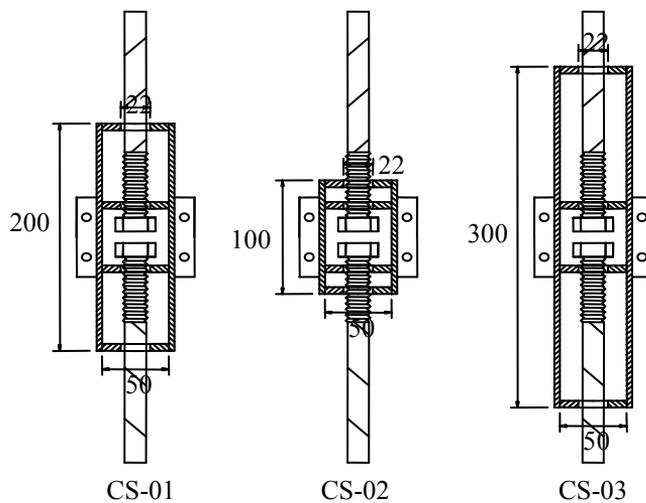
Figure 7: Details of specimen CS-01, CS-02 and CS-03

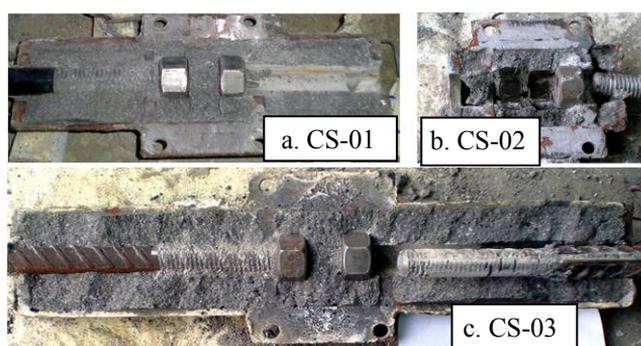
Figure 8: Failure mode of specimen CS-01, CS-02 and CS-03

The internal conditions and the failure modes of specimens CS-01, CS-02 and CS-03 are illustrated in Figure 8. Reinforcement bars of CS-01 and CS-03 slipped leaving behind the smooth surface of crushed grout keys. Meanwhile, the grout in CS-02 crushed, leaving behind the nut stuck at the opening of the steel plates due to failure of threads that hold the nut and reinforcement bar together.

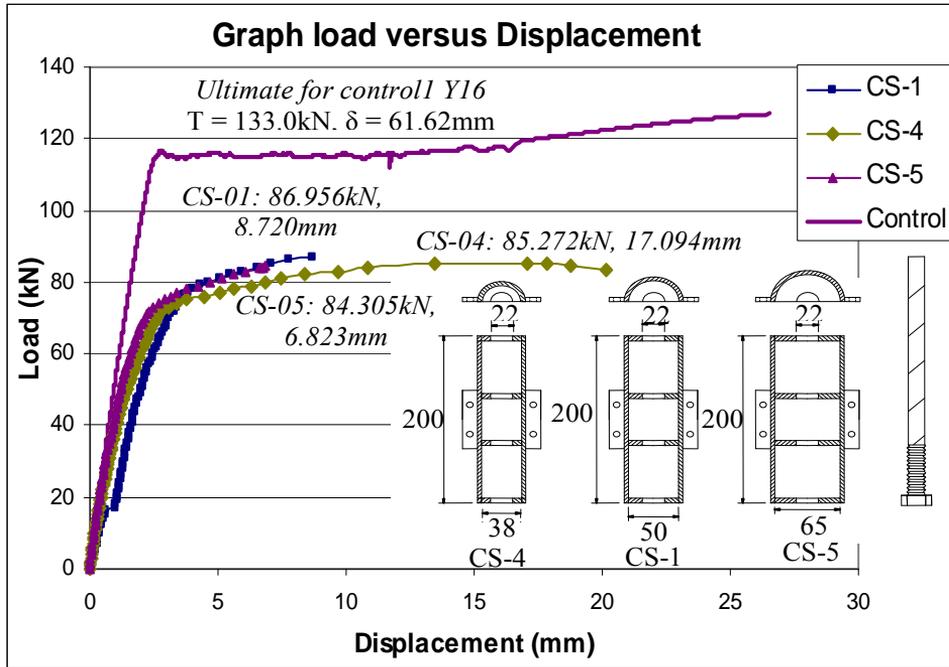
Figure 9 plots the graph of load versus displacement of specimens CS-01, CS-04 and CS-05. It studies the effects of different sizes of sleeve, in terms of cross sectional area, towards loading performance of the sleeve. Basically, despite of sudden displacement of specimen CS-01 at 17kN, the structural performance of the specimens appeared to be similar (ultimate loading capacity and stiffness ratio). It seems that the similarity in embedded length of reinforcement bars in grout-filled sleeve will lead to similar ultimate loading capacity, of which the specimens recorded 86.965kN, 85.272kN and 84.305kN

accordingly. Specimens CS-04 and CS-05 were also similar in stiffness ratio and the rate of decreasing rate of stiffness ratio. The load-displacement curve in Figure 8 showed that all the specimens underwent degradation of stiffness ratio as the pulling force reached 70kN. It was the instant where minor cracks and progressive shear failure occurred as the grouts in the sleeve had reached their capacities.

Figure 9: Graph load versus displacement of specimens CS-1, CS-4 and CS-5

Specimen CS-04 presented larger displacement among the specimens. The load-displacement curve indicated the occurrence of progressive crushing of the grout in it, of which was interpreted from the obvious sudden displacement represented by the plots in load displacement curve (at around 82kN loads).

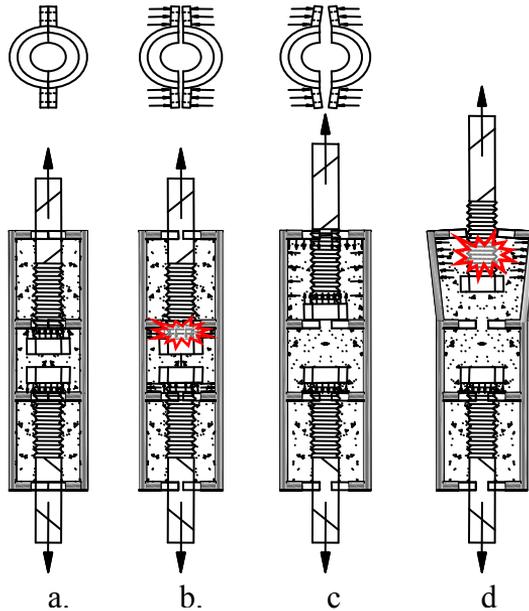
As pulling force was applied onto the reinforcement bars at the opposite directions, the nuts that clamped onto them tended to displace together with the reinforcement bars towards the directions of the pulling forces. The interlocking effect of the nut caused distributed load onto the grout surrounding it (Figure 10a) and brought the grout to move along towards the direction as well. However, it was resisted by the steel plates at the middle of the sleeve. This induced compressive force onto the grout. The compression force deformed the grout and caused it to expand laterally. However, the lateral force was resisted by the circular sleeve. As the incremental gain larger, the lateral expansion also

Figure 10: Failure mechanism of specimen CS-04

The grout crushed and large lateral force was generated at all direction (Figure 10b). This had forced semi-circular sleeve to expand towards the weaker axis, where the bolt and nut system gripped the together. Therefore, the opening of the middle steel plate in the sleeve gain larger until it exceeded the size of the nut. Then, the steel plates at the middle of the sleeve could no longer provide interlocking effect to the nut and reinforcement bar. As a result, the reinforcement bar, as well as with the nut, slipped out of the opening, inducing strong compressive force on the grout behind the steel plate (Figure 10c). This also triggered crushing on the grout as it had already exceeded the compressive capacity of the grout. At the meantime of compression, it also caused lateral expansion force. However, the double semi-circular sleeve could not generate enough resistance towards the expansion force as the bolt and nut system provided could only resist the lateral expansion at the middle of the sleeve. Therefore, the sleeve split and rotated outward slightly. The rotation split of the sleeve and the crushing of the grout caused large displacement of reinforcement bar (Figure 10d). Therefore, the specimen ended with 17.094mm displacement at ultimate loading capacity of 85.282kN (Fig 11).

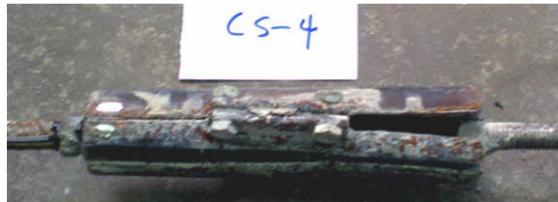
Figure 11: Dislocation of reinforcement bar with nuts on it caused one end of sleeve to split

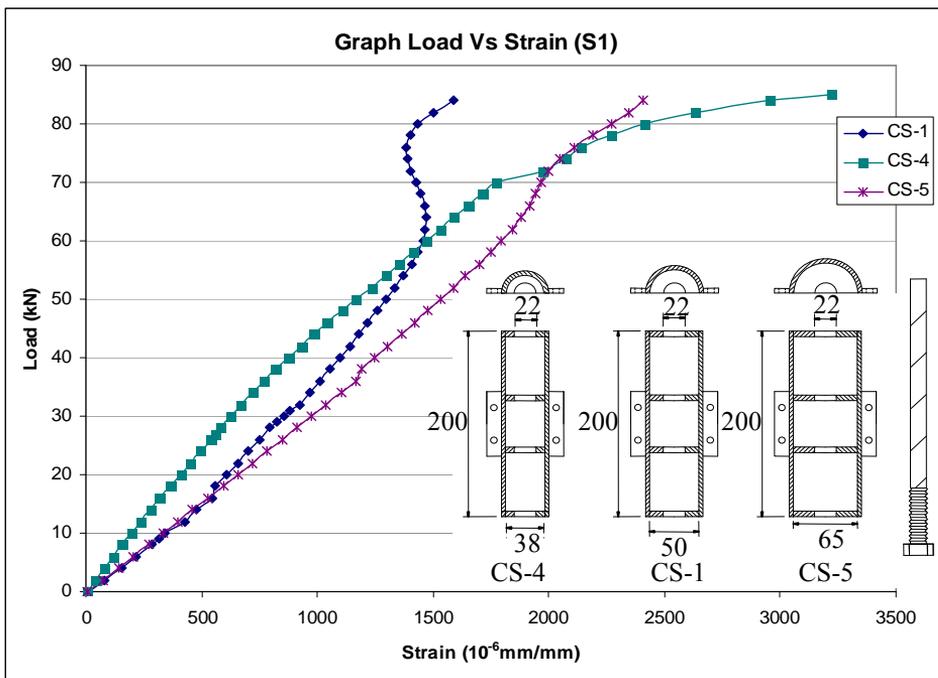
Figure 12: Load strain graph of reinforcement bars in CS-01, CS-04 and CS-05

Figure 12 plots the load-strain graph of the reinforcement bars in specimens CS-01, CS-04 and CS-05. It shows that specimens CS-01 and CS-06 slipped because their load-strain curve showed slight decrease of strain condition at around 80kN before further development of strain in reinforcement bars. They slipped before the reinforcement reached its yield.

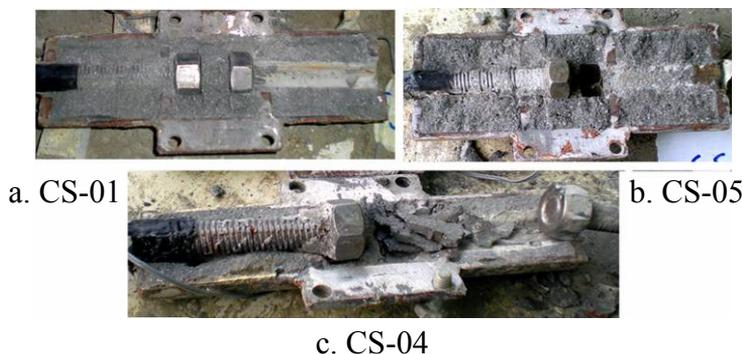
Figure 13 illustrates the comparisons of failure modes for specimens CS-01, CS-04 and CS-05. The extreme pulling forces caused the threads on the nut and reinforcement

bar to fail, leaving the nuts remained in the sleeve while the reinforcement bars were pulled out of the sleeve (Figures 11a and 11b). On the other hand, specimen CS-04 underwent progressive crushes that led to severe lost of load transferring medium that ensure the continuities of the reinforcement bar, and therefore, it failed.

Figure 13: Failure modes of specimen CS-01, CS-02 and CS-05

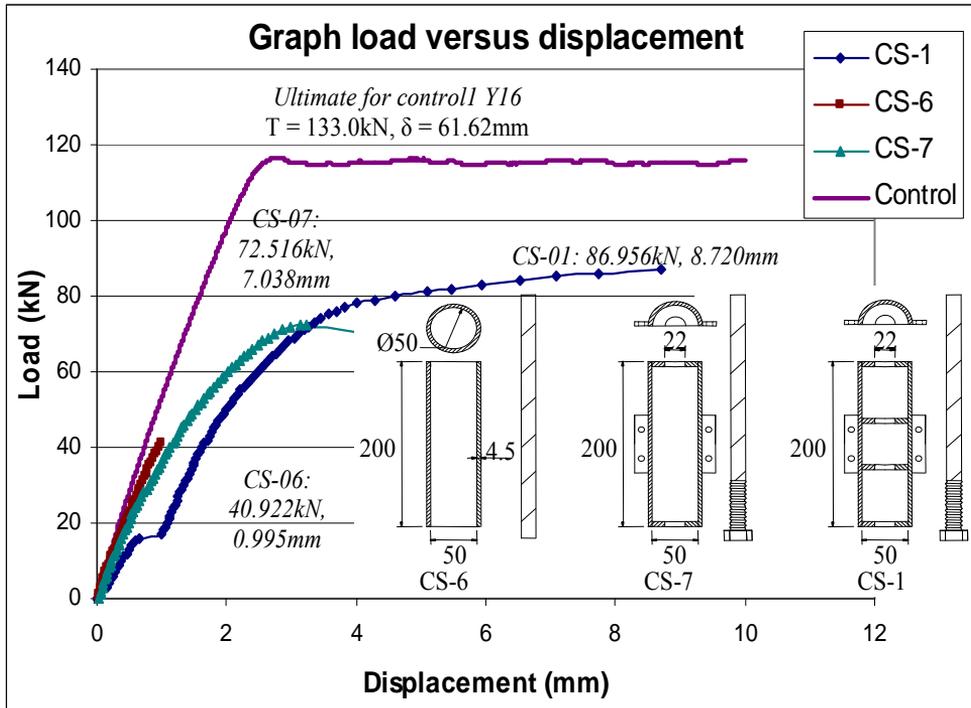
Figure 14 presents the graph of load versus displacement for specimens CS-01, CS-06 and CS-07. This study investigates the effects of steel plates welded in the sleeve to the ultimate loading capacity of the specimens. Specimen CS-01 had four steel plates welded on the semi-circular sleeves, two at both ends, while another two in the middle of the sleeve. Specimen CS-07 had only two steel plates welded at the both ends of the sleeve. Meanwhile, specimen CS-06 consisted of a pure steel cylinder without any steel plate welded on it (the specimens are as illustrated in Figure 13).

The ultimate loading capacities of specimens CS-01, CS-06 and CS-07 were 86.956kN, 40.922kN and 72.516kN respectively. These specimens failed in different manners (Figure 15). At ultimate state, the reinforcement bar in specimen CS-01 slipped and being pulled out of the sleeve; the grout in CS-07 crushed as it reached its compressive strength; the grout in CS-06 failed in tensile. It split and the grout slipped out of the sleeve. Therefore, it was observed that the configuration of the sleeve could

Figure 14: Graph load versus displacement of specimen CS-01, CS-06 and CS-07

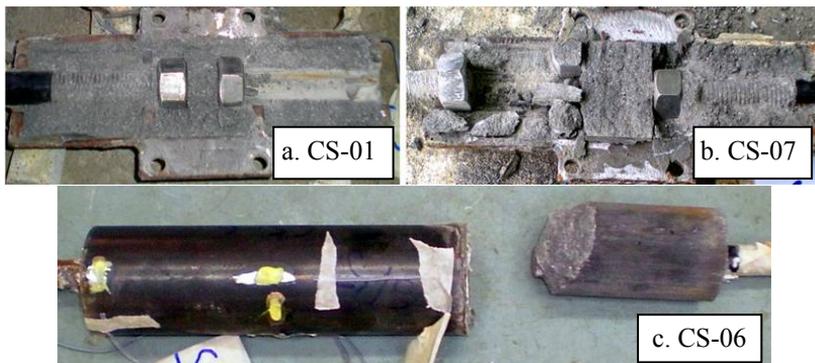
directly influence the loading capacity of the sleeve. The grout used for the sleeves were from the same mix, of which their compressive strengths were similar. However, specimen CS-07 failed in crushing while CS-01 did not.

Figure 15: Comparison of failure modes of specimen CS-01, CS-06 and CS-07

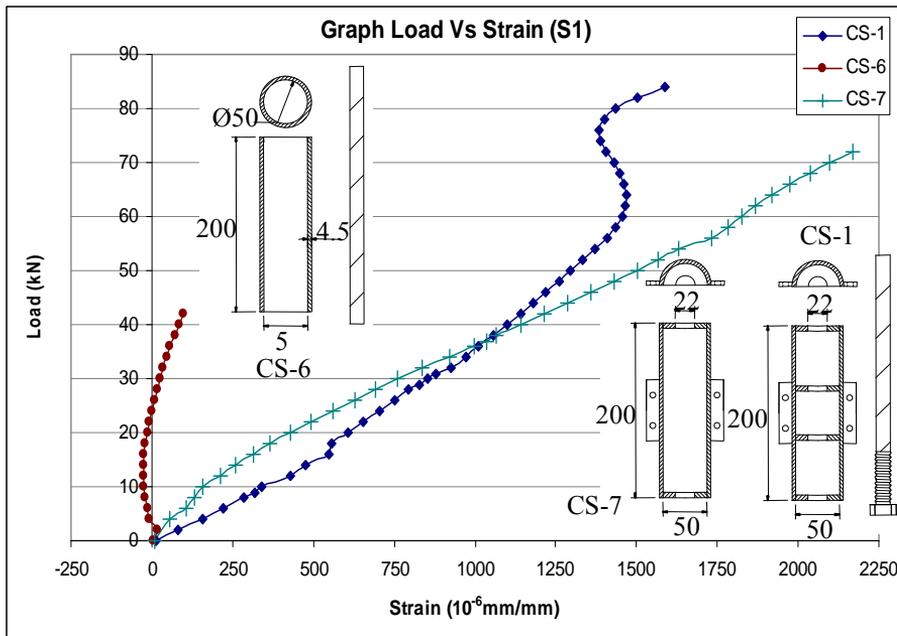
Figure 16 plots the load-strain graph of the reinforcement bars in specimens CS-01, CS-06 and CS-07. None of the reinforcement bars yielded during the loading period. The reinforcement bars in specimen CS-06 showed as if did not contribute in load resisting mechanism as it recorded negligible development of strain reading. Improper configuration of sleeve unable to restrain the grout from slipped out of the sleeve. The grout was very weak in tensile and it relied on the friction between the sleeve and the grout to provide tensile resistance. As pulling force was applied, the stress concentrated at the discontinuity of the reinforcement bars. Then, the tensile resistance of the grout and the friction of the sleeve surface took part in preventing the grout from slipping out of the sleeve. Both of them were very weak and therefore, the specimen failed at very low loading

Figure 16: Load-strain graph of the reinforcement bars in specimens CS-01, CS-06 and CS-07

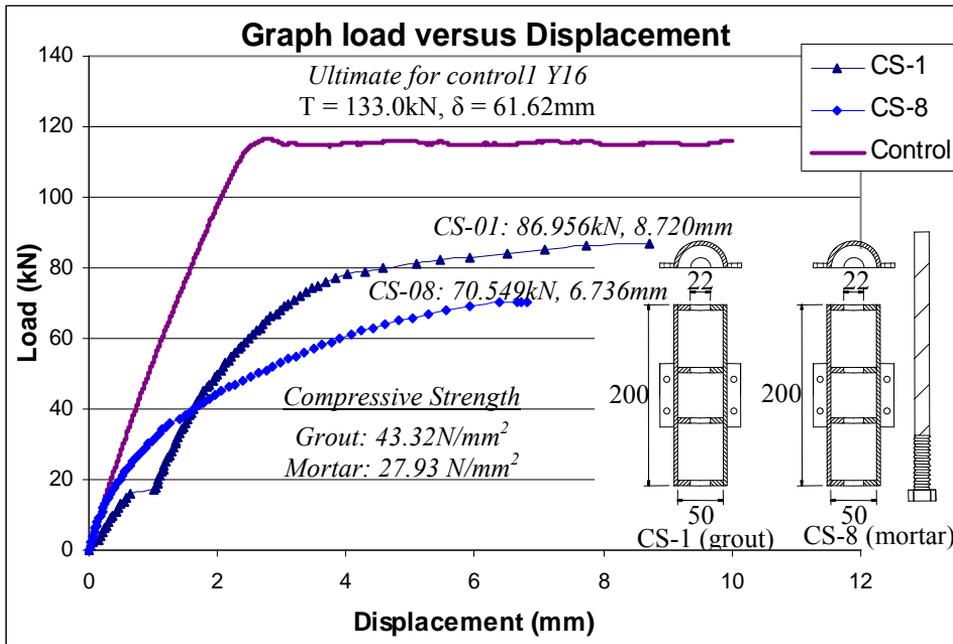
Figure 17 presents the graph of load versus displacement of specimen CS-01 and CS-08. The configuration of the sleeve for the specimens was similar except that CS-01 utilized grout (43.32N/mm²) while CS-08 utilized mortar (27.93N/mm²) as load transferring material. Specimen CS-01 could sustain up to 86.956kN while CS-08 offered 70.549kN of ultimate tensile resistance.

Figure 17: Graph load versus displacement of specimen CS-01 and CS-08

From the load-displacement graph in Figure 17, at initial stage, specimen CS-08 offered higher stiffness ratio as compared to specimen CS-01 as it underwent relatively less displacement as compared to CS-01. Then, the displacement development rate increased gradually until the load-displacement curve intercept with curve of CS-01 at approximately 1.5mm. The load resisting capacity of CS-08 was reaching its yield while CS-01 was yet to reach its capacity. Therefore, after the interception, CS-01 outperformed CS-08. Both the specimens underwent similar mode of failure, of which both of them had their reinforcement bar slipped out of the sleeve, while the nut remained inside the sleeve (Figure 18).

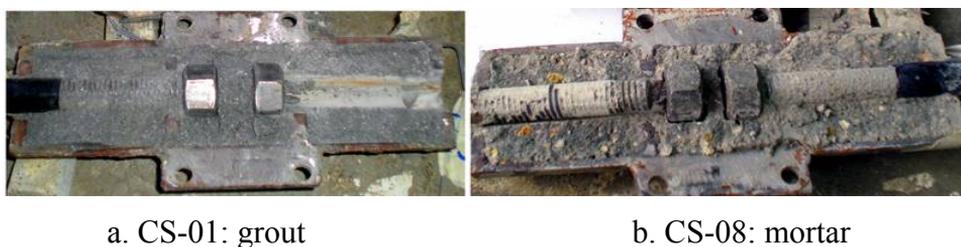
Figure 18: Comparison of bonding medium used in specimens CS-01 and CS-08

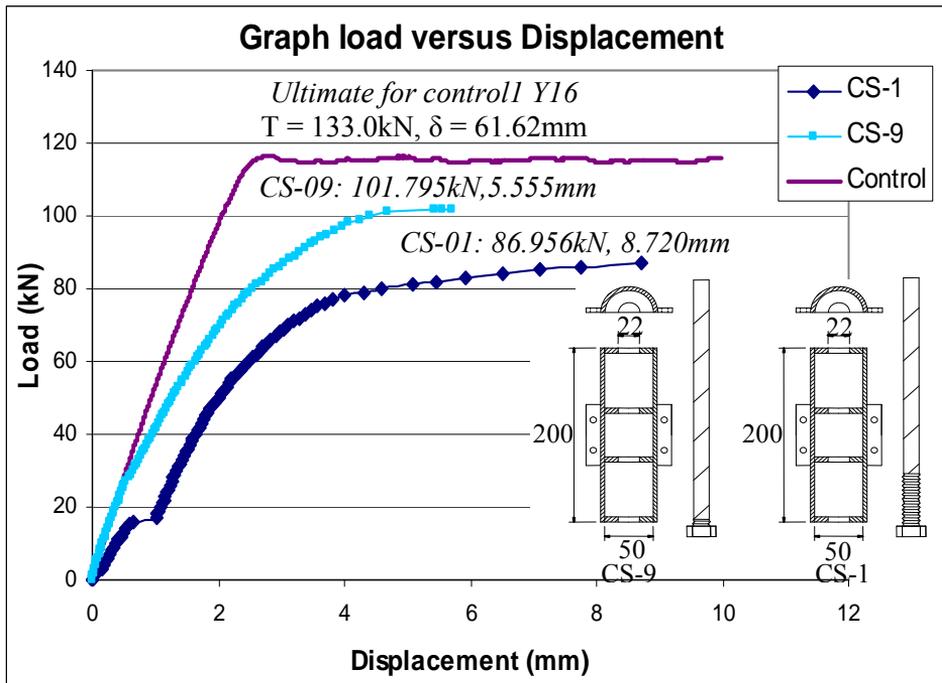
Figure 19 illustrates the graph of load versus displacement of specimens CS-01 and CS-09. This study investigated the effects of the threads towards the structural performance of the sleeve. CS-01 utilized threaded steel bar to be embedded in the sleeve, while CS-09 utilized deformed reinforcement bar in the sleeve. The result showed that deformed reinforcement bar provided better bonding properties. The thread on the reinforcement bars led to higher bearing/shear area and it had significantly affected the bonding capacity of the specimens. The grout keys between threads had limited shear areas to resist the pulling force and hence reinforcement bar slipped at 86.956kN as compared to specimen CS-09 of 101.795kN.

The mechanical interlocking property provided by the ribs on the deformed reinforcement bar not only enhance the bonding property of the specimen, it also led to higher stiffness ratio, of which it underwent slightly less displacement as compared to specimen CS-01 with threaded reinforcement.

Figure 19: Graph of load versus displacement of specimen CS-01 and CS-09

Figure 19 shows the graph of load versus displacement of specimens CS-01 and CS-09. This study investigates the effects of the threads towards the loading performance of specimen. Threaded reinforcement bars were embedded in specimen CS-01, while ordinary reinforcement bar was used in specimen CS-09. The outcomes showed that specimen CS-09, with ordinary rib pattern, had outperformed the threaded reinforcement bar in specimen CS-01. This was due to the strong mechanical interlocking between bar ribs and grout keys. CS-09 presented higher stiffness ratio as compared to CS-01 because it had better bonding property. Specimens CS-01 and CS-09 underwent similar failure

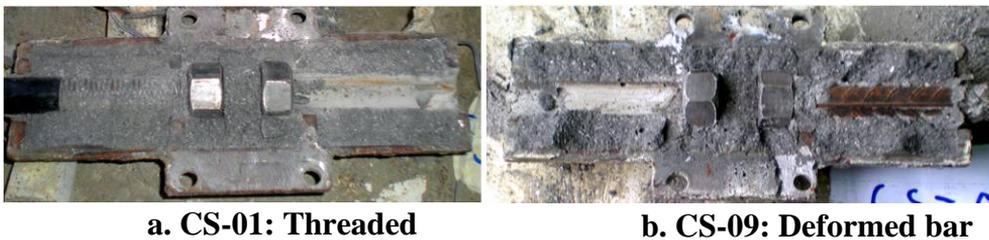
Figure 20: Failure modes of specimen CS-01 and CS-09

mode, of which both of the specimens had their reinforcement bars slipped and being pulled out of the sleeve (Figure 20).

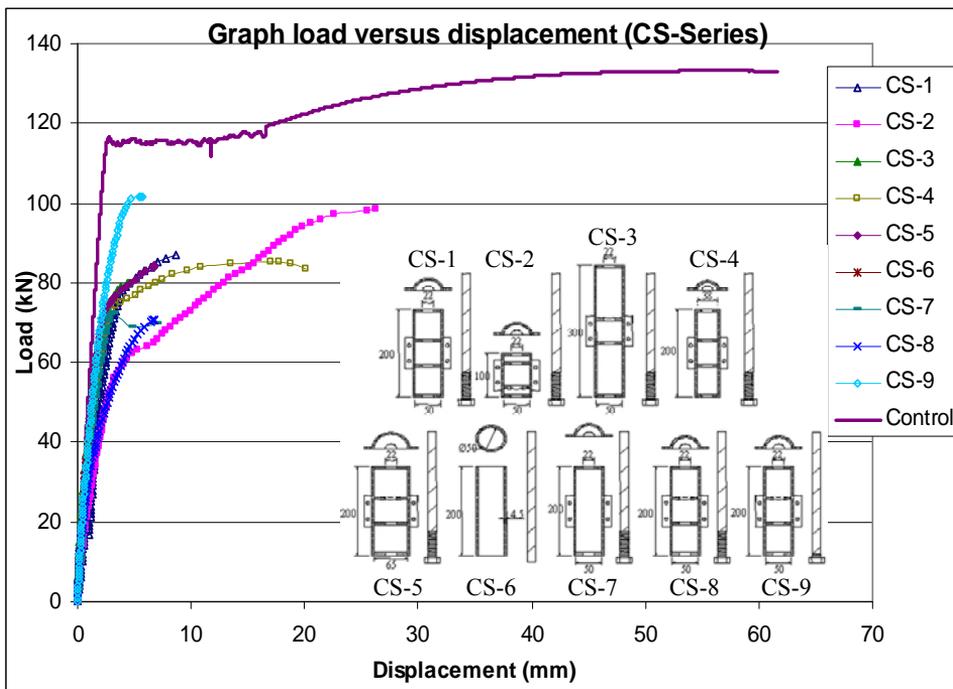
The understanding obtained from the study are (1) reinforcement bar rib pattern should not be threaded in order to ensure optimum performance of bonding mechanism other wise it will affect the bond property between grout and reinforcement bar, (2) better bonding property will lead to high stiffness ratio of the specimen. Figure 21 illustrates the plots of all the specimens of this study and obviously, specimen CS-09 offered the best structural performance (101.795kN), while specimen CS-06 gave the least loading capacity of 40.922kN.

Figure 21: Load-displacement graph of all the specimens in the study
