# PROPERTIES OF CEMENT BASED COMPOSITES CONTAINING OIL PALM STEM AS FIBER REINFORCEMENT

Dianah Mazlan & A.S.M. Abdul Awal\*

Department of Structures and Materials, Universiti Teknologi Malaysia  
81310 Skudai, Johor Bahru, Malaysia.

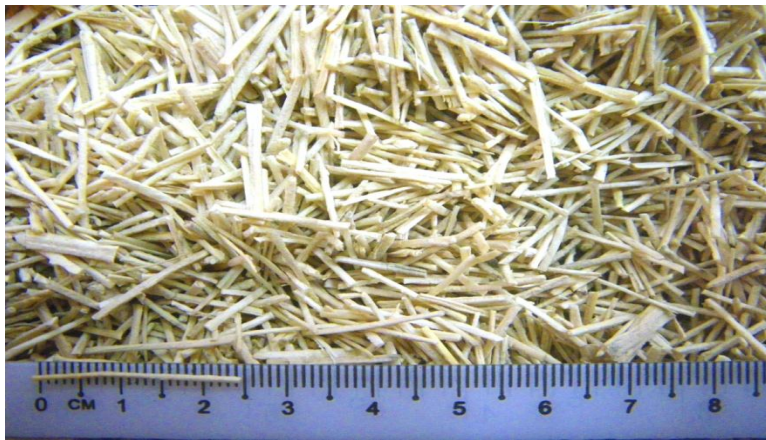
Figure 1: Cut and treated oil palm stem fiber.

In this study the fibers were soaked in hot salty water for about 15 minutes to remove all kinds of dirt and to prevent any microbial deterioration thereby improving the quality of fibers. Finally, the fibers were oven dried for 24 hours at a temperature of about 45°C as to make sure that there is no water in the fiber. Figure 1 shows the treated and cut oil palm stem fibers that are ready to be mixed with mortar. It is generally understood that the bond between a mortar and fiber with rough surface will be stronger than that of the smooth surface (Gram, 1988). Interestingly, the existence of rough surface of palm fiber as illustrated in Figure 2 would be a contributing factor in the development of bond strength of mortar matrix. A flow chart showing the preparation of materials and testing program is illustrated in Figure 3.

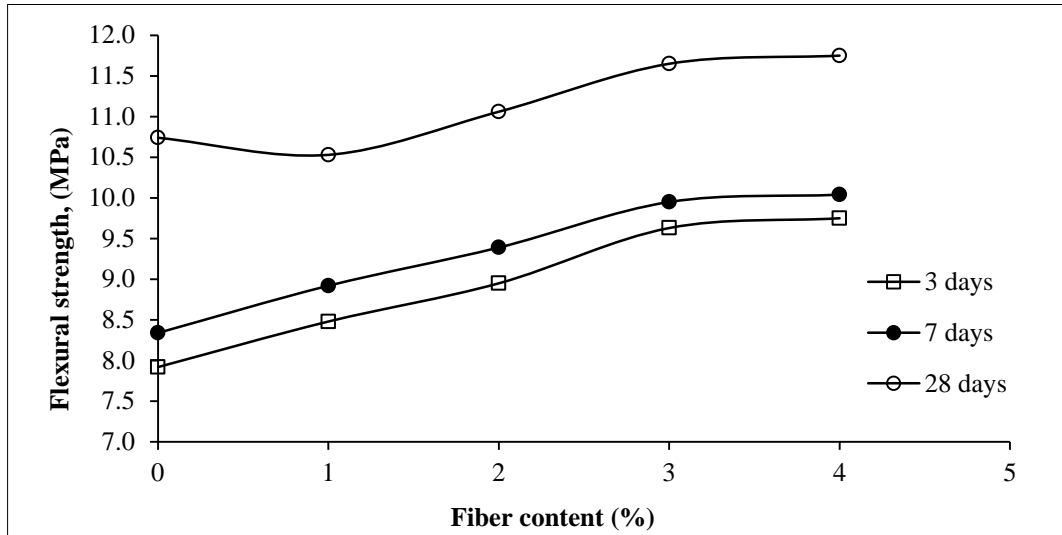
Figure 9 illustrates the flexural behavior of mortar containing oil palm stem fiber in three different ages of 3, 7 and 28 days. The higher the percentage of oil palm stem fiber added, better was the performance of concrete in flexure. Although the flexural strength kept increasing with the increase of fiber content, the development of strength was prominent for to up a certain limit of 3% fiber content.

Figure 9: Flexural strength of mortar containing oil palm stem fiber.

An important aspect that can be outlined from the experimental results is the ductility and tenacity of mortar containing oil palm stem fiber when fiber content volume is increased. This phenomenon could be due to the higher deformability and energy absorption of the mortar during the cracking phase. Interestingly the mortar containing oil palm stem fiber showed a higher bending stiffness and a different cracking pattern than the normal mortar. Most cracks showed a reduced width appearing from casting surface due to the presence of oil palm stem fiber, which tend to move to the lower portion of the specimen.
