BOND DURABILITY OF STEEL PLATE TO CONCRETE PRISM USING STRUCTURAL ADHESIVES AFTER EXPOSURE TO 7-YEARS IN LABORATORY ENVIRONMENT

Keywords: Epoxy bonding, steel plate, pull out Test, durability, tropical condition

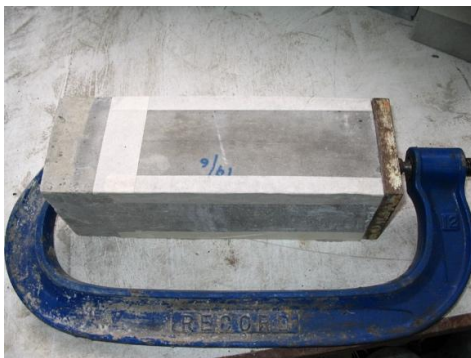
Figure 1: Concrete prisms attached with G-clamp prepared in 2008

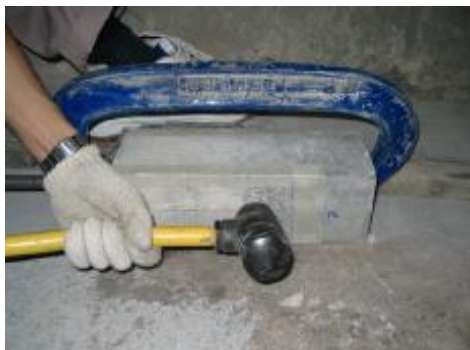
Figure 3: Hacking with air tool hammer

Initially, concrete prisms with good surface quality were chosen. The margins or borders were marked using masking tape. The bonding length of the steel plates is 200 mm. An extra 10 mm tolerance was provided around the bonding regions. Before the hacking process was carried out, one of the bonding edge was installed with a 10 mm steel plate, attached using G-clamp as shown in Figures 1 and 2. This was to protect the concrete edge from peeling off during the hacking process using air tool hammer and the depth of the hacked surface was around 2 mm. The preparation process of the concrete surface is shown in Figures 3 and 4.

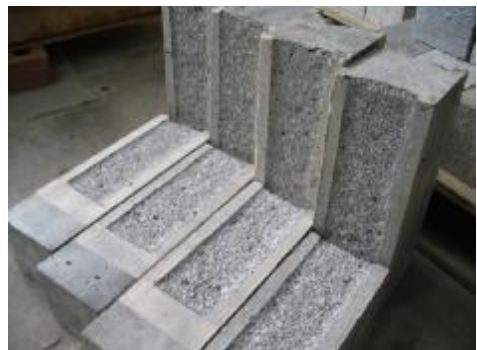
Figure 4: Readily hacked concrete surface

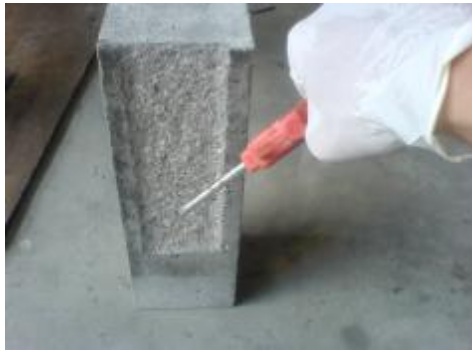
Figure 5: Surface cleansing to remove dust using air compressor

The first step of the bonding works is the cleaning of the concrete surface as shown in Figure 5. The concrete prism was installed onto a specially made rig instrument for accurate bonding. A suitable amount of epoxy was applied onto the bonding surface and later the steel plate was pressed onto the epoxy. Excessive epoxy was removed and the edges were chamfered. An imposed load was applied as shown in Figures 5 and 6.

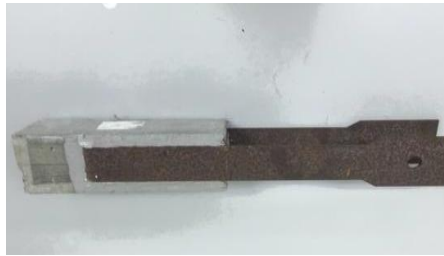
Figures8: SPECS-7 with corroded steel plate

The sample (SPECS-7) that was used in this study is approximately 7 years old with the steel plates outer surface was corroded and being compared with sample (SPECS-1) tested in 2008. However, before undergoing tests, the steel plate has to be de-rusted and cleaned from any form of impurities for strain gauges installation. Figure 8 shows the 7-year sample with corroded steel plates. Figures 9 to 11(b) show the sample preparations prior load test.

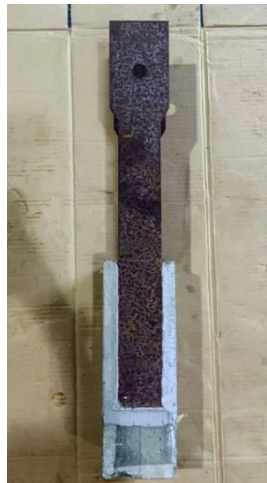
Figure 9: SPECS-7 before the application of rust remover

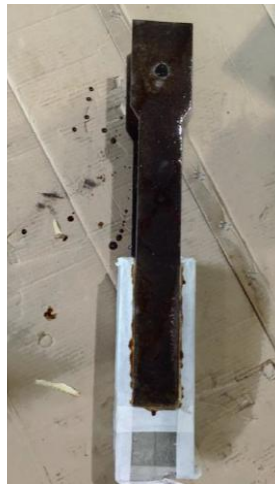
Figure 10: SPECS-7 after the application of rust remover

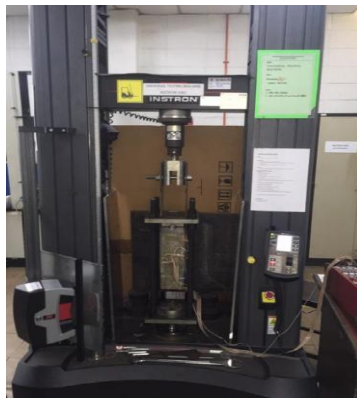
Figure 14: Instron 5982 Universal Testing Machine

After all the necessary preparation work, SPECS-7 was installed in the way as shown in Figures 14 to 16. A tensile load was applied vertically until failure. All wires linking to the strain gauges were connected to a data logger to render the readings.

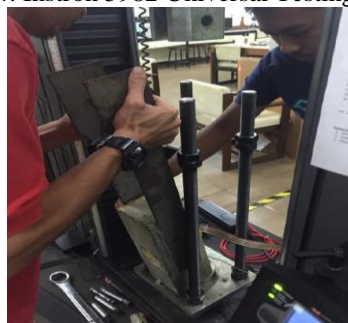
Figure 15: Installation of pull-out test rig

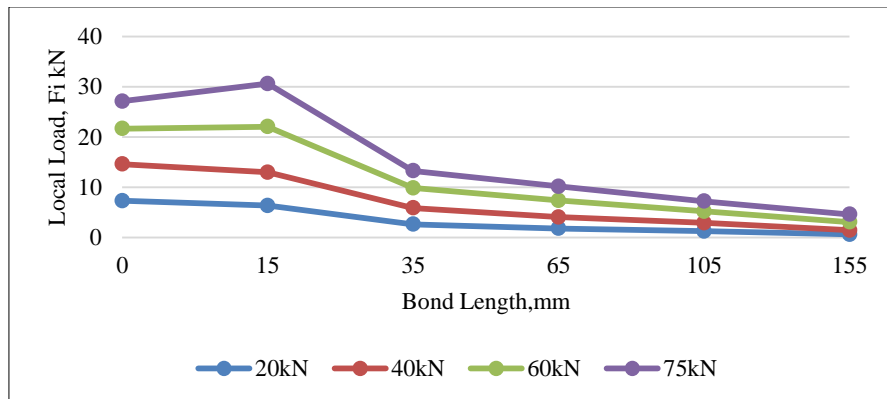
Figure 19: Local Load versus Bond Length for SPECS-7

From Figure 19, it is observed that the local loads are higher in the beginning of the bond length. As the bond length increases pass the 35mm mark, there is linear decrease in the local load distributions. This may well indicate that at the earlier lengths of bond, the force transfer from the steel plate to the adhesive is very much high and the bulk of the stress are concentrated at this region. The distribution of local forces in the 0 to 35 mm bond region clearly shows an exponential trend as compared to results from sample SPECS-1.

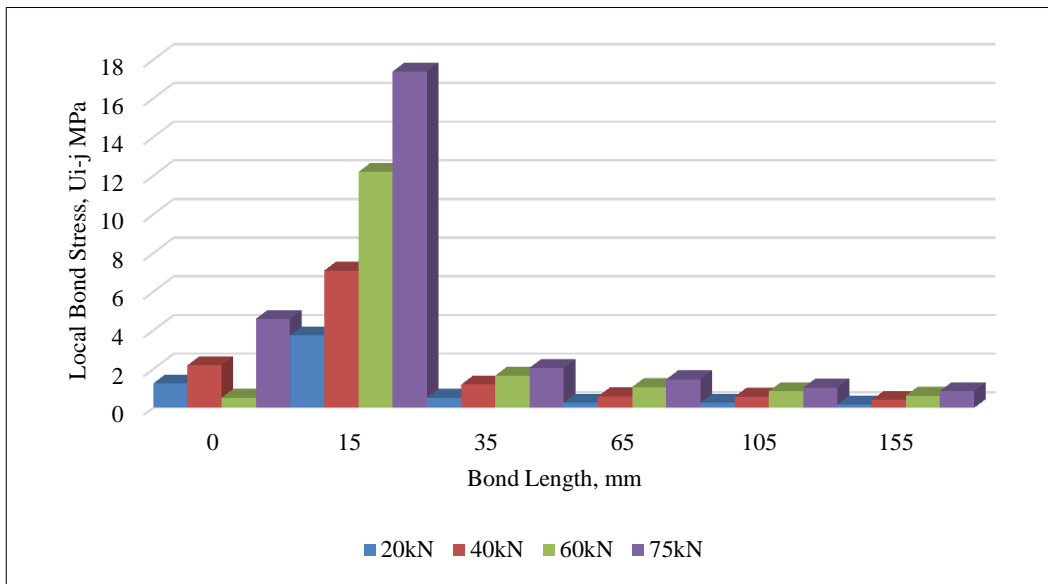
Figure 20: Local Bond Stress versus Bond Length at various load levels for SPECS-7

As shown in Figure 20 above, comparisons of the local bond stresses are made between the different load levels. As previous test for SPECS-1 prove, the local bond stresses are significantly high at the end of the bond lengths. The stresses recorded at 35mm to 105mm mark, tells us that the force distribution is much more uniform across the centre bond length of the plates.

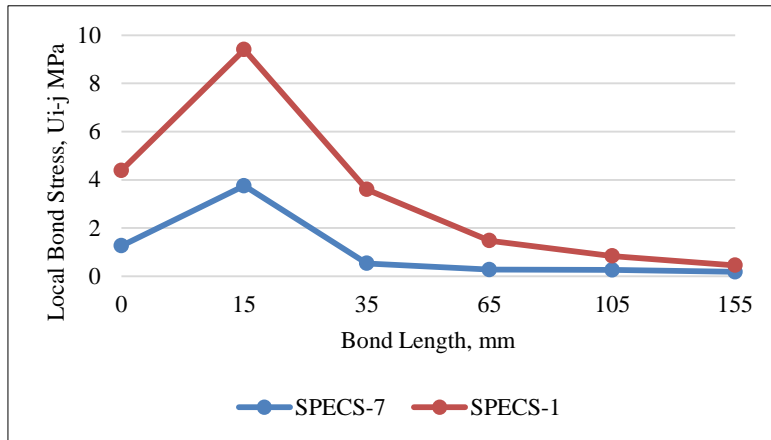
From the data obtained by test conducted to sample SPECS-1, we can compare the information and investigate the reason behind the different end results. Figure 21 illustrates a comparison between two samples at 20kN load level. Clearly from the graph, it is shown that SPECS-1 specimen underwent relatively higher stress values and the curved graph indicates that the distribution of local longitudinal forces and shear stress along the bond are exponential. For SPECS-7, The trend is almost the same except

for lower bond stress values recorded. SPECS-1 also shows much more uniformly distributed stresses along the bond length.

Figure 21: Comparison at 20kN Load level for SPECS-7 and SPECS-1

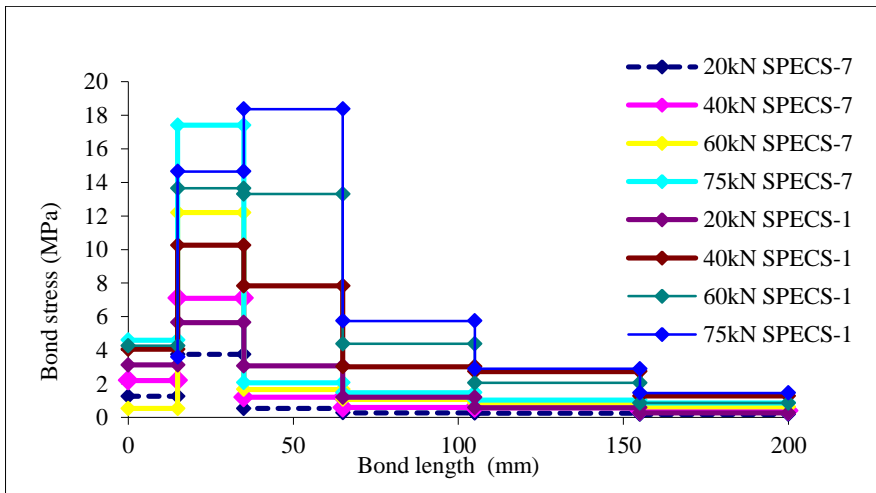
Figure 25: Comparison of local bond stress versus bond length between SPECS-7 and SPECS-1

Figure 25 above presents a comparison on local bond stress at various bond length between SPECS-7 and SPECS-1. The stress distributions along the bond length show that for SPECS-7, the local bond stresses are much lower and linear towards the end of the bond length. Sample SPECS-7 also recorded lower local bond stresses at the same applied loads as compared to SPECS-1.

At all load levels indicated, SPECS-7 recorded lower local bond stress levels. Although SPECS-1 bond failure occurred at double the amount of time recorded for SPECS-7, this shows that the bond strength at a much matured ageing period is far stronger than a 1 month old specimen. We can say from the data provided, that SPECS-7 bond is brittle and hard and SPECS-1 has a much more ductile behaviour.

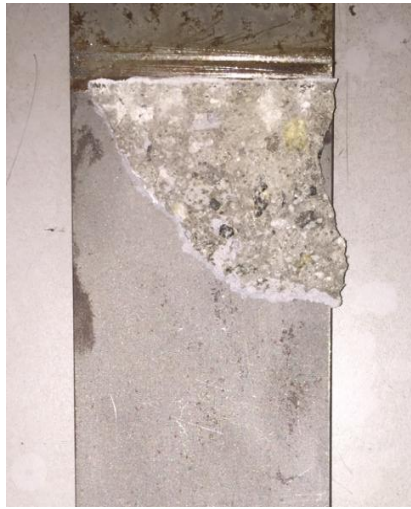
Figure 27: Formation of concrete bulb on steel plate after failure

The failure zones suggest that failure was a combination of adhesion at the steel – epoxy interface and cohesion due to epoxy failure. The 7 year aging of the bond between both epoxy and concrete may have shown encouraging signs, but the steel to epoxy bond is suspect in bond suitability of both materials. Comparing the data obtained from the strain gauges, we can relate the high strains recorded at the gauges closest to the datum. The physical observation of the specimen verifies this as the concrete fracture across bond lengths 0mm to 35mm.

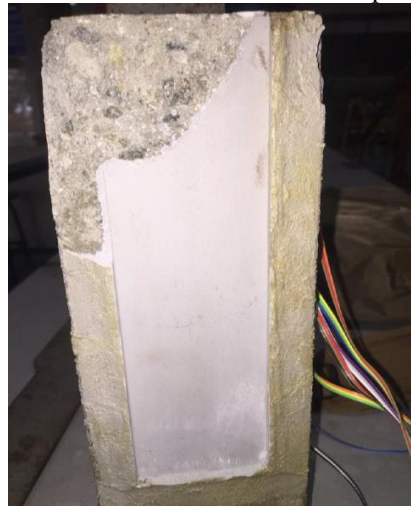
Figure 28: Concrete from SPECS-7 after failure
